# PIC32MZ EF FAMILY

## PIC32MZ Embedded Connectivity with Floating Point Unit (EF) Family Silicon Errata and Data Sheet Clarification

The PIC32MZ Embedded Connectivity with Floating Point Unit (EF) family of devices that you have received conform functionally to the current Device Data Sheet (DS60001320D), except for the anomalies described in this document.

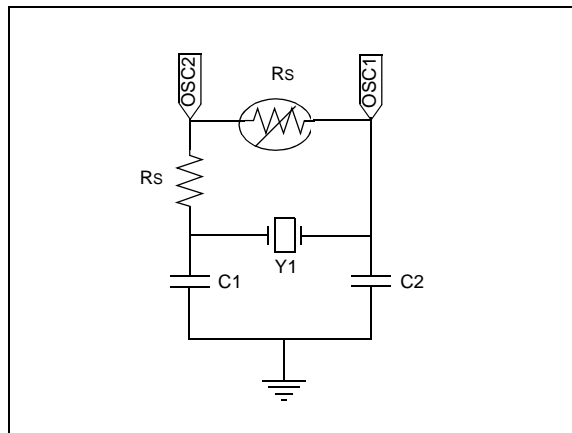
**FIGURE 1: POSC CRYSTAL CIRCUIT**

**Revision A1 Silicon:** A crystal oscillator cannot be used as an input to the Primary Oscillator (Posc) pins OSC1 and OSC2.

**Revision A3 Silicon:** The Posc has been tested in a normal power-up sequence and supports specific crystal operation.

The Primary Oscillator (Posc) has been characterized to operate at 8 MHz, 12 MHz, and 24 MHz when the circuit in [Figure 1](#) is implemented, and the operating conditions listed in [Table 3](#) are met.

**TABLE 3: CRYSTAL SPECIFICATIONS**

Crystal Frequency (see Note 1)	Series Resistor (Rs)	Posc Gain Setting POSCGAIN<1:0> (DEVCFG0<20:19>)	Posc Boost Setting POSCBOOST (DEVCFG0<21>)
8 MHz	2 kΩ	'0b00 (GAIN_0)	'0b1 (ON)
12 MHz	1 kΩ	'0b00 (GAIN_0)	'0b1 (ON)
24 MHz	0 kΩ	'0b00 (GAIN_0)	'0b1 (ON)

**Note 1:** Using any other crystal frequency will require special component selection and characterization.  
**Note 2:** A shunt resistor (Rshunt) should not be used to increase the gain of the POSC.
